SUMP STUDIES: I - TERRAIN DISTURBANCES, 1978.

Sump Studies: I  
Terrain Disturbances

H.M. French,  
Department of Geography and Regional Planning,  
University of Ottawa.

Published under authority of the  
Hon. J. Hugh Faulkner, Minister  
of Indian and Northern Affairs Canada,  
Ottawa, 1978.

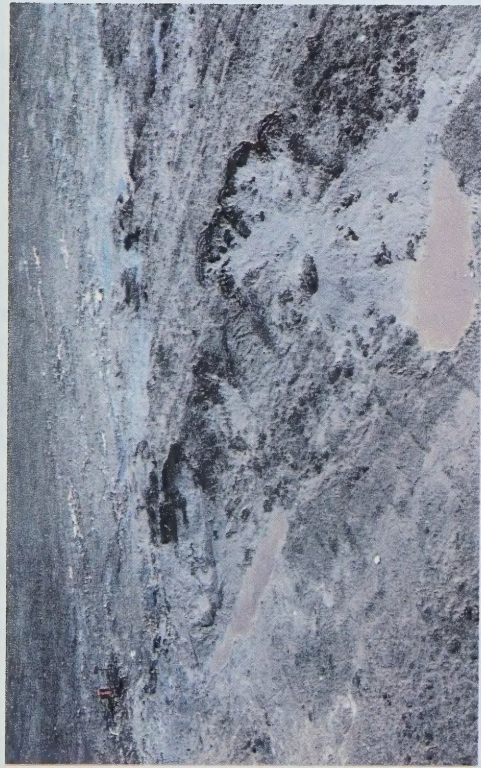
The wellsite was located in one of the damper, vegetated areas of the Beaufort Plain. In an attempt to minimize damage, the surface organic mat had been scraped clear of the site and heaped together for use in restoration. The sump exhibited signs of post restoration slumping (Figure 4 a) and waterlogging. Since the well had been drilled the previous winter and the site abandoned only three months prior to the visit, slumping was actively occurring. Presumably, the failure reflected low effective stress and low shear strength consequent upon the melt-out of snow mixed with the sump infill material, together with a seepage of water into the sump from adjacent areas.

Fig. 4 (a) Post-restoration slumping at the Panarctic Elf Bar Harbour E-76 wellsite, northwest Banks Island, July 8, 1976.

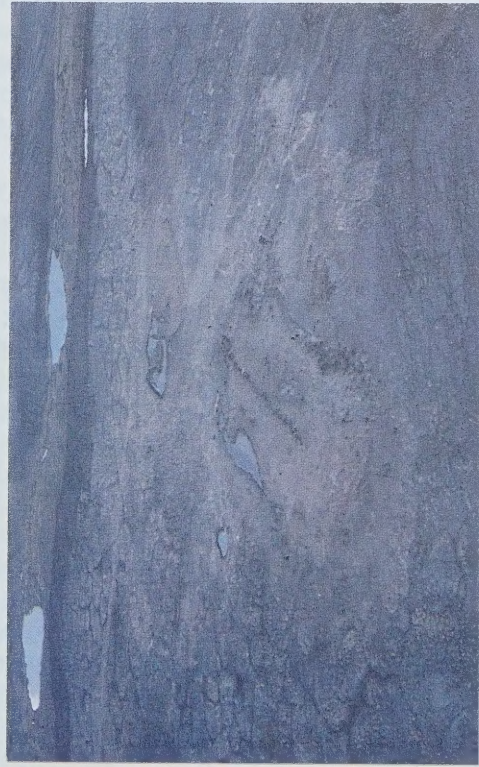
Fig. 4 (c) Air view of Elf Kusrhaak D-16 wellsite, north central Banks Island, July 10, 1976.

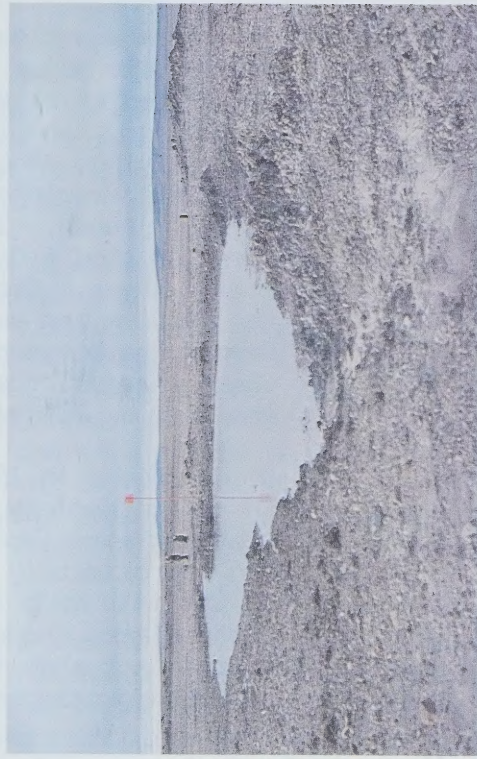
Fig. 4 (d) Ground view of standing water body formed along upslope side of the sump, Kusrhaak D-16, July 10, 1976.

In theory, this water body constitutes a "heat sink" which may induce thermal degradation of the sump overburden. Observations of active thermokarst processes on Banks Island suggest that there are very few instances where water bodies of these dimensions would lead to marked or rapid thermokarst. A further concern expressed in 1975 was the possibility of gullying along the various frost fissures which underlie the site, in a similar manner to those which have developed at the Deminex Orksut 1-44 site on the Big River (French, 1976 b, op. cit.), and at the Gulf Parsons Lake site N-10 in the Mackenzie Delta. Such gullying has not occurred at the Kusrhaak D-16 site and now seems unlikely to occur in the future.

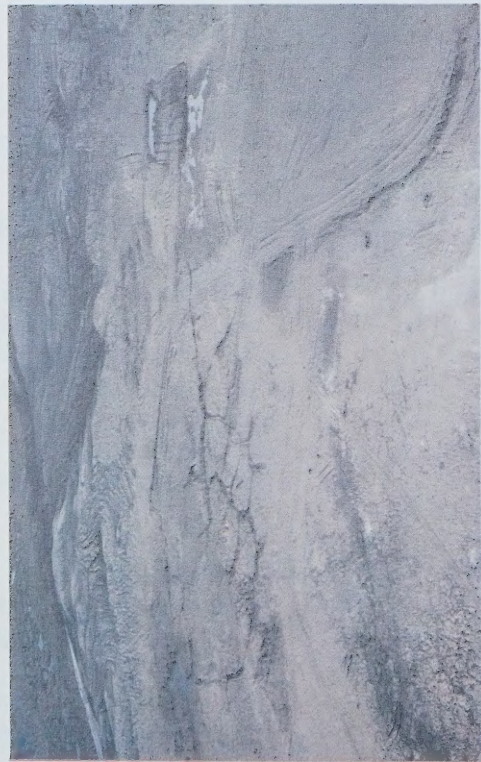
In July 1976, only the site of the summer twin otter airstrip and the disturbed terrain resulting from the infilling of the living quarters' sump were visited. The crude polygonal network of shallow gullies, observed in 1975 and thought to reflect preferential melt along the lines of underlying ice wedges, had further developed into a well defined pattern draining downslope towards the site of the wellhead (Figure 5 a). The hummocky micro-relief of the disturbed borrow pit area had increased to 2.0 m in relative relief and continued to be actively subsiding. Pools of standing water occurred in some of the depressions.

Fig.5(a) Air view of crude polygonal gully network developing at a borrow pit, Deminex Orksut 1-44 wellsite, southern Banks Island, July 10, 1976.

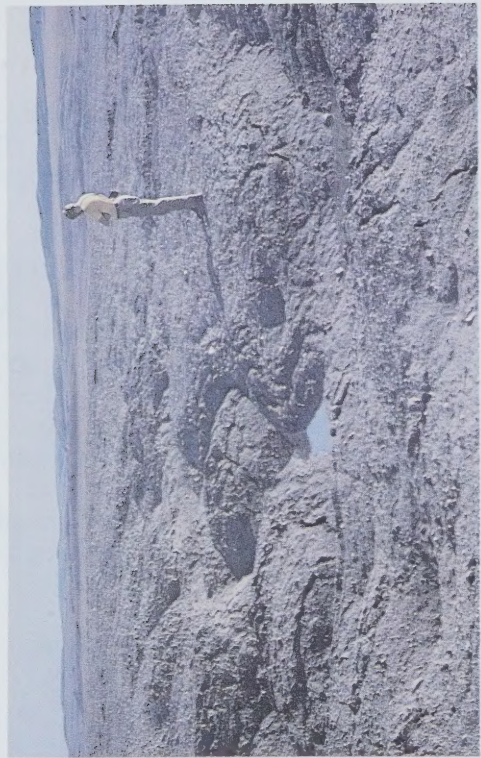
In 1977, the borrow pit topography showed little change from 1976 (Figure 5 b). However, the airstrip had undergone subsidence in a number of places and landing was now marginal for fixed wing aircraft. Depressions as great as 1 m deep had developed in several places and the whole strip possessed an uneven, undulating appearance. Thaw depths measured beneath the airstrip were significantly higher than in adjacent terrain. Also, the airstrip showed signs of dampness not apparent in undisturbed terrain, a phenomenon observed by others elsewhere (e.g. Price, Bliss and Svoboda, 1974).

It is likely that the unusually high summer temperatures experienced on Banks Island in 1977 were responsible for this recent subsidence. At the time of the visit for example, an air temperature of  $+17^{\circ}\text{C}$  was recorded. In general, the Western Arctic experienced unusually warm temperatures during the summer of 1977 and this probably induced regional thermokarst activity.

Fig. 5(b) Typical thermokarst topography occurring at Orksut I-44 site, August 16, 1977.

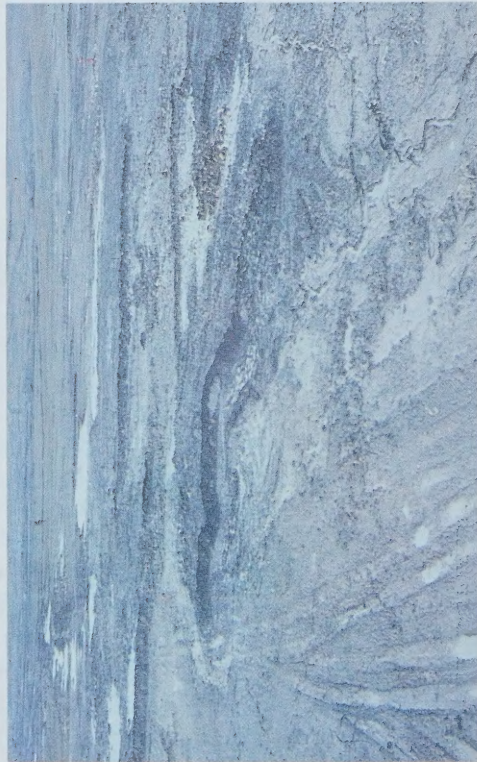
Fig.5(c) Oblique air view of Drake D-68 wellsite, eastern Melville Island, August 7, 1976.

Of the five wellsites examined, it is significant that only one, D-68, was a deep well (17,766'), and this was the site at which slumping of the sump was observed. The large volume of drilling muds required for D-68 and the associated large sump may be significant factors. Moreover, D-68 was started in June 1973 and completed in March 1974, thus spanning a summer season. All the other wells were completed during their respective winter drilling seasons.

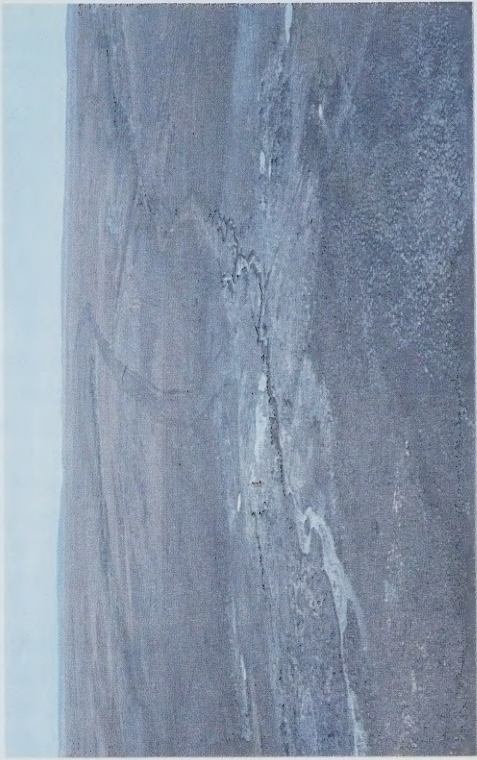
Fig.5(d) Air view of Drake B-44 wellsite, Sabine Peninsula, Melville Island, August 7, 1976.

Problems at B-44 do not relate to the sump infilling or to terrain disturbance but to site characteristics. Although the lease is on a gently sloping coastal platform, the wellsite is downslope from an ephemeral stream which originates in rising terrain approximately 300 m inland (Figure 5 d). The sump is currently being eroded by this stream, which may lead to the eventual release of drilling fluids. A summer pre-inspection would have anticipated this problem and required that the well be located approximately 100 m to the south.

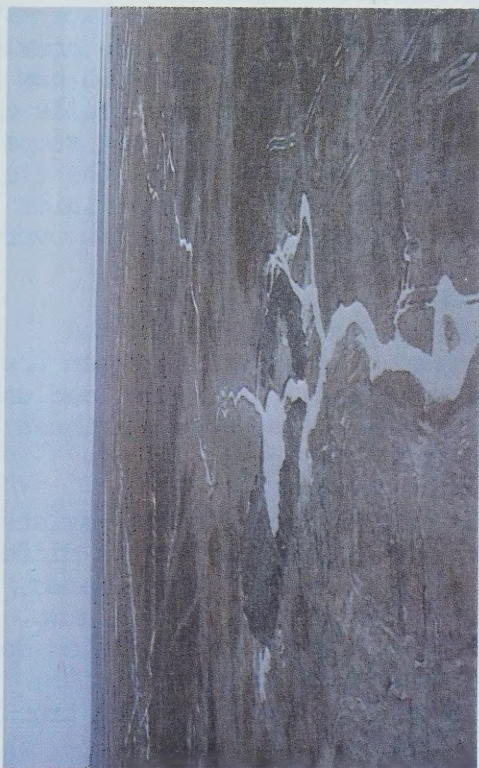
Fig.6(a) Air view of collapsed sump at Hecla J-60, Sabine Peninsula, eastern Melville Island, August 9, 1976.

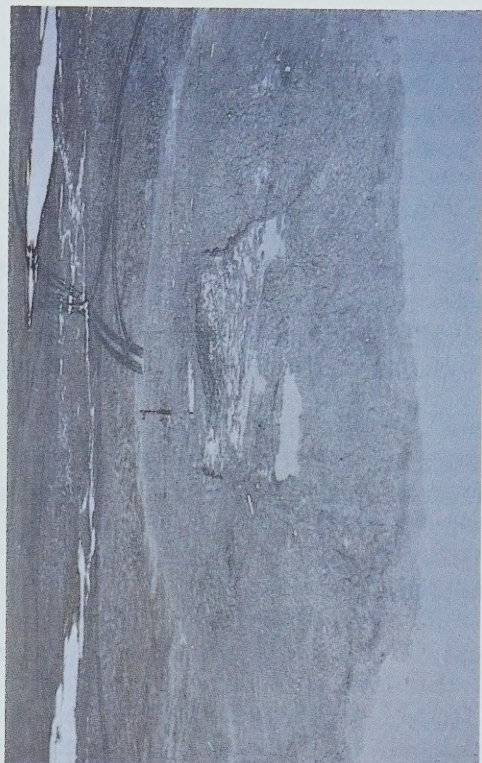
The Hecla F-62 and I-69 wells are located at the waters' edge. At F-62, the rig sump has slumped and now drains to the sea while the kitchen sump is below sea level; it would seem that this well, when drilled in November 1972, was actually offshore, probably in 3-4' of water. At Hecla I-69, the sump is partially underwater and the seaward end has been completely eroded (Figure 6 b). Several semi-circular slumps, draining to the sea, occur on the landward half of the sump. Since these two wells were shallow (both less than 5,000') and relatively straightforward winter drilling operations (both completed in less than two months), the sumps are not large. At I-69 however, sump fluids escaped during the drilling operation since the sump was clearly of insufficient size to contain the waste effluent.

Fig.6(b) Air view of sump at Hecla 1-69, Sabine Peninsula, August 9, 1976.

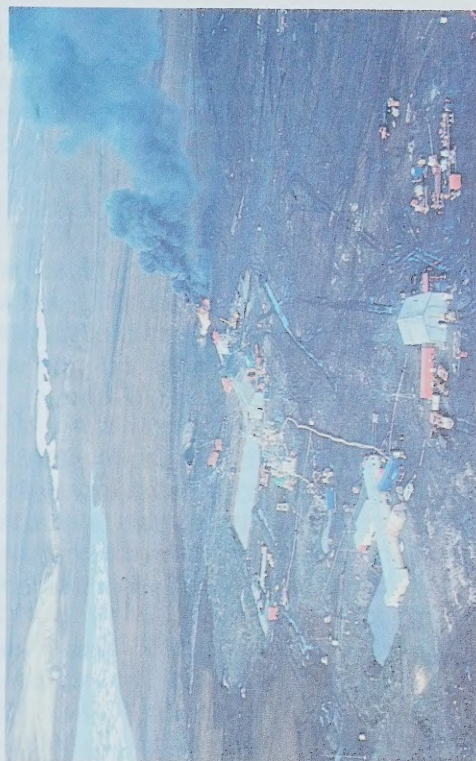
Fig.6(d) Air view of Panarctic Bent Horn A-02 well-site, August 14, 1976, illustrating terrain disturbance.

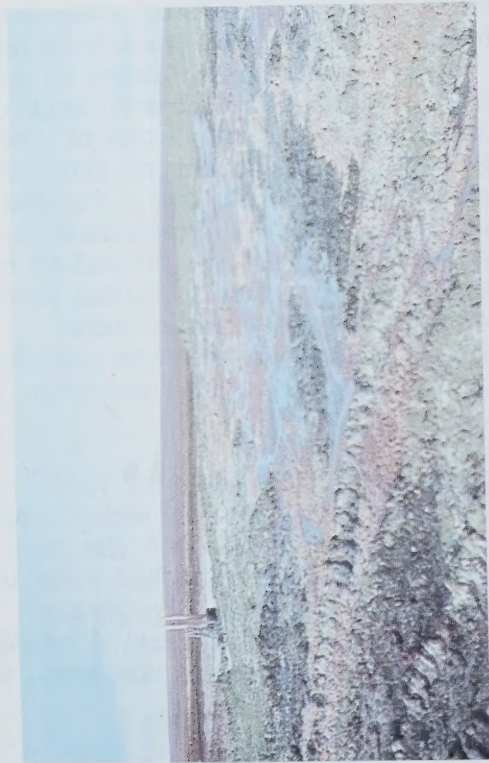
Infilling of the sumps took place in late spring of 1977. When inspected in August 1977, the first sump was waterlogged and drilling fluids were present at the surface of the main sump (Figure 7 a). In all probability, the sump had been too full when infilling took place and frozen fluids probably became mixed with the sump infill material. A lack of easily accessible gravel, with which to form a cap over the sump, was a further problem.

Fig. 7(a) View of main sump at Bent Horn I-01, August 10, 1977, approximately 5 months after sump infilling.

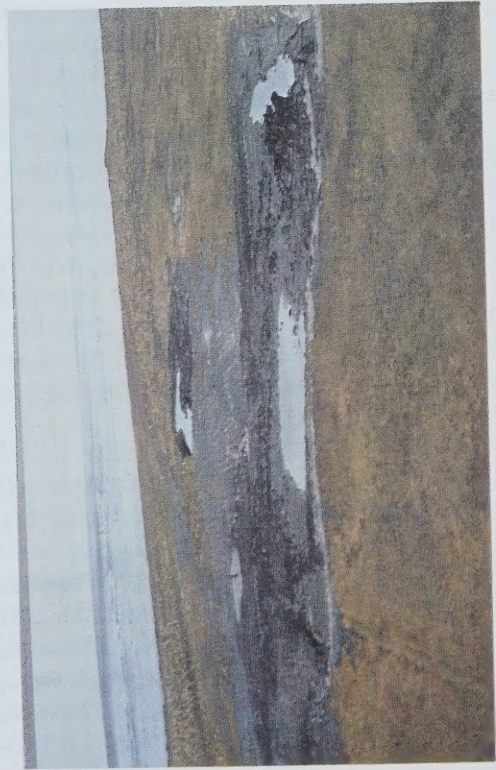
Fig. 7(c) Air view of Shell Niglintgak M-19 wellsite, September 10, 1976.

Sump problems at all sites relate to a lack of infill material (Figure 7 c). This reflects the very high ice content of the underlying silts and the melt-out and volume loss which occurs during summer. The most apparent material deficiencies occur at Niglintgak M-19, a late summer/early winter operation drilled between June 1974 and January 1975, and Niglintgak H-30, where the sump remained open during the summer of 1973.

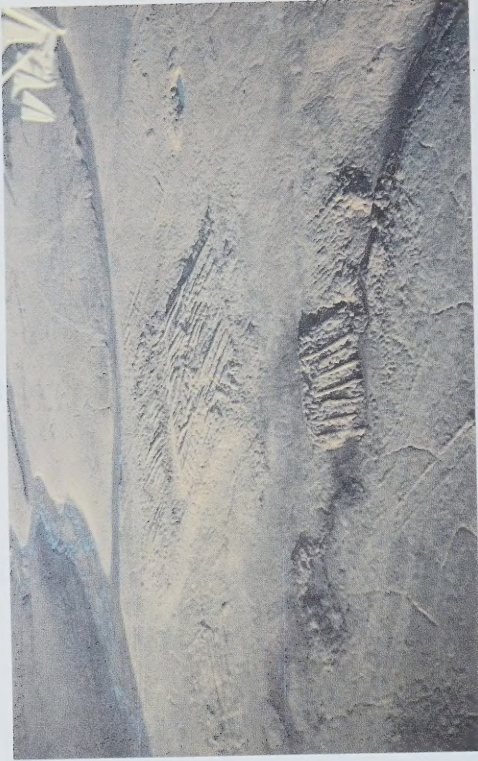
Fig. 7(b) Air view of restored sump at Elf Dyer Bay I-59 wellsite, Prince Patrick Island, August 16-17, 1976.

These two sites were visited in August 1976. No sump problems were observed at either (Figure 7 b). Both wells were drilled in winter and both are located on sand and gravel, I-59 underlain by Beaufort Formation and J-51 by Wilkie Point Formation sandstone. Both sites are typical of true polar desert environments. Temperatures measured in the active layer at these sites illustrate how drilling operations in such areas pose minimal environmental or terrain problems. There was little difference between disturbed and undisturbed terrain (Table 2). In general, the observations made on Ellef Ringnes and Amund Ringnes Islands support this view.

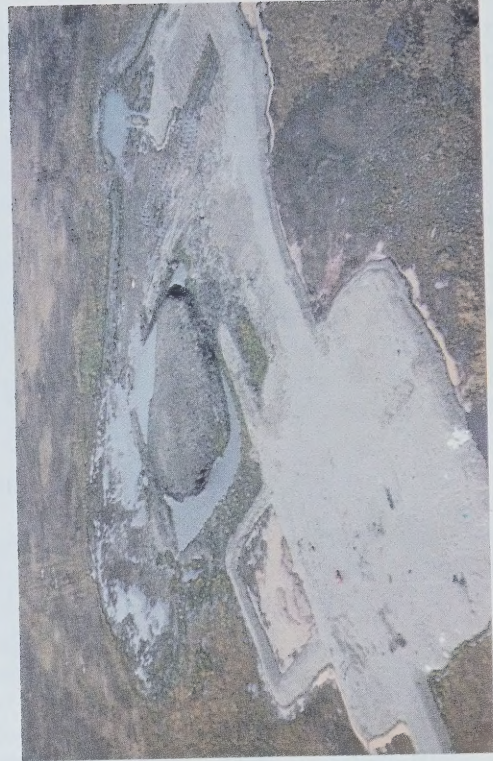
Fig. 7(d) Air view of Imperial Taglu F-43 wellsite, Mackenzie Delta, September 9, 1976.

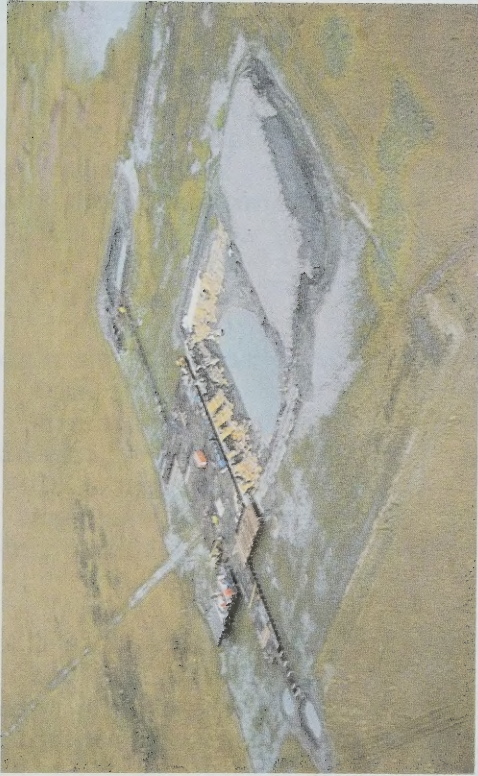
The spring flood of 1976 was higher than usual and completely covered the site. At one point the drilling platform was covered with 4' of water. The dyke around the sump was of insufficient height and the sump became infilled with water. In July, after water levels had fallen, the sump was pumped out but subsidence and slumping of the sump had already begun since the insulation matting had been disrupted. Because a new sump would be required and because this could only be constructed in mid or late winter when ice thicknesses were sufficient to allow movement of heavy equipment along ice roads, it was not possible to complete the well during the 1976-77 winter drilling season. Accordingly, the company abandoned the site.

Fig. 8(a) Air view of proposed Tullugak wellsite, Mackenzie Delta, September 10, 1976.

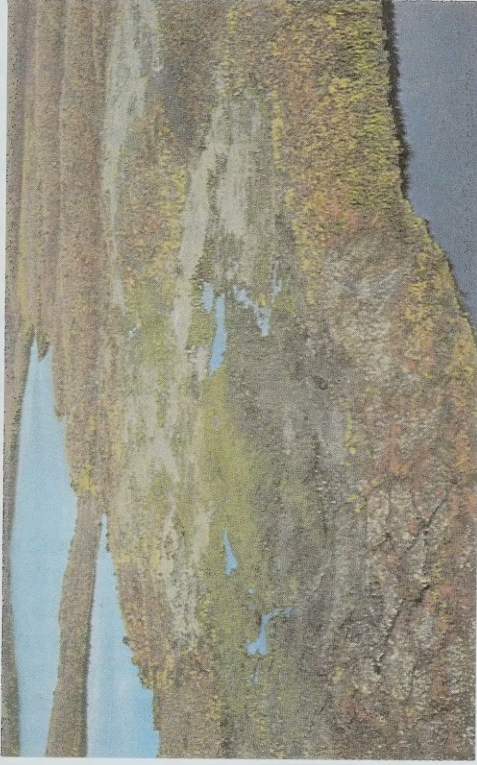
Fig. 8(b) Air view of Gulf Parsons Lake N-10 wellsite, Mackenzie Delta, September 10, 1976.

On May 13, 1973, fluids were reported leaking beneath a dyke constructed at the lower southeast corner of the sump and entering a nearby lake. Several samples of the fluids were found to be toxic to fish upon analysis. The sump was left

open during the summer. In July, further leaking from the sump occurred, causing considerable gullying along the ice wedges on the slope leading towards the lake.

It might be argued that, on account of the topographic and permafrost conditions at the site, the Parsons Lake N-10 well might best have been drilled without a sump.

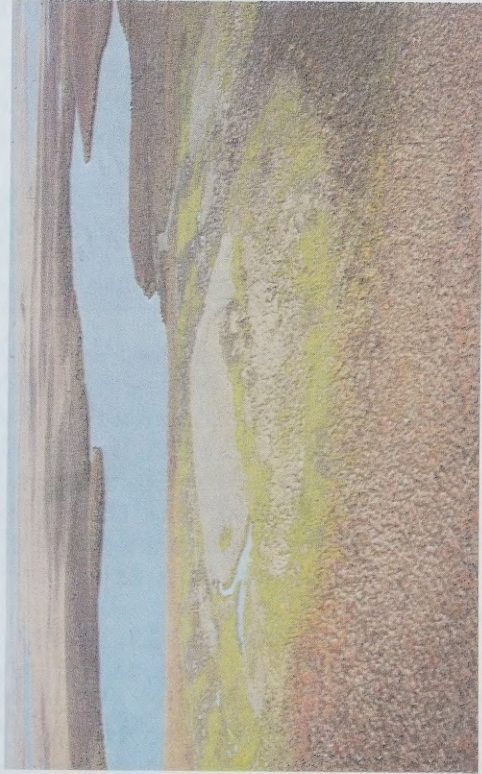
Fig. 8(c) Air view of Gulf Parsons Lake A-44 wellsite, Mackenzie Delta, September 10, 1976.

At the Parsons Lake A-44 wellsite (Figure 8 c), IAND records indicate that the lower half of the sump was excavated in massive ice. Moreover, drilling continued throughout the

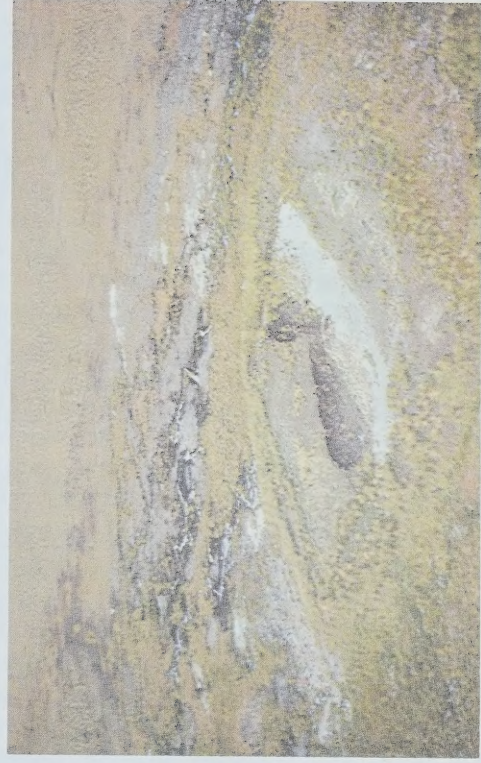
Fig. 8(d) Air view of Shell Beaverhouse Creek H-13 wellsite, on sloping upland terrain on west side of Mackenzie Delta, September 8, 1976.

This well was drilled in the winter of 1970-71. It is located on a sloping (3-5°) upland tundra surface on the foothills of the Richardson Mountains. The slump has collapsed along the downslope edge (Figure 8 d). In addition, the site was a shallow wet depression used as a seepage line. Revegetation around the site was good however, and apart from the sump, site restoration appeared successful.

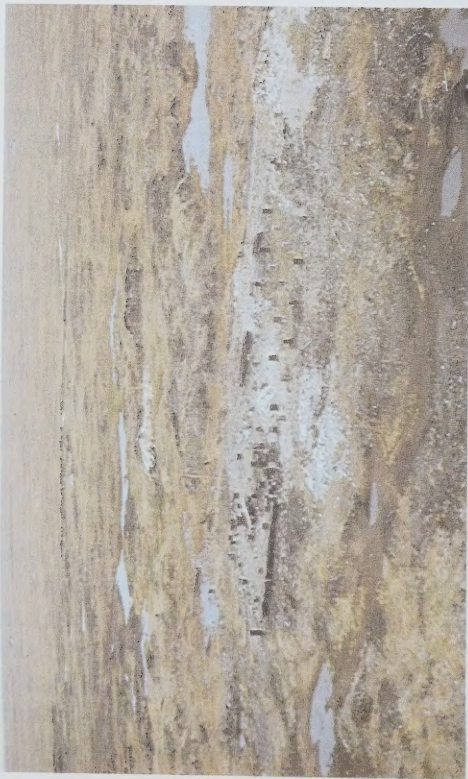
Fig.10(a) Air view of Simpson Test Well No. 29, U.S. National Petroleum Reserve (NPR-4), Alaska, showing old rig pad and waste drilling muds, June 28, 1977.

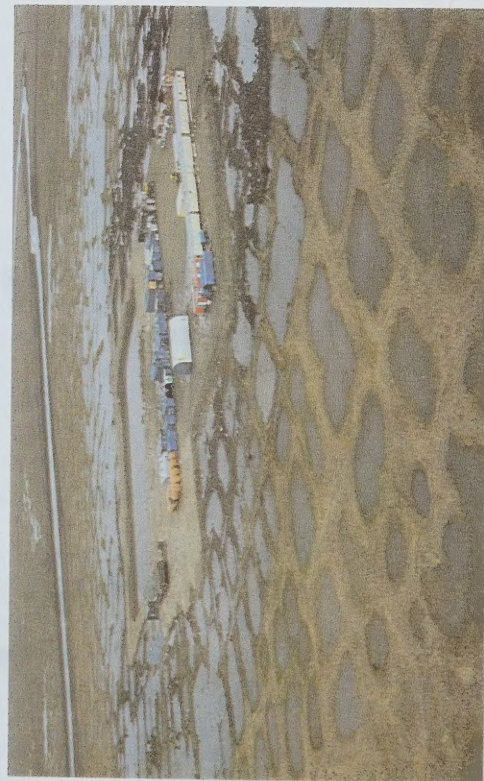
Fig.10(c) Air view of Husky Oils (NPR) Operations Ltd., South Simpson Wellsite, NPR-4, drilled in 1976-77, June 30, 1977.

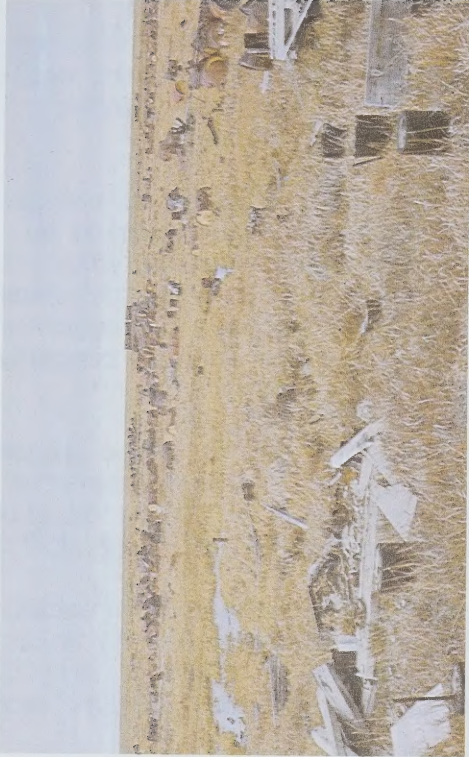
The Old Fish Creek well-site, drilled during the summer of 1949, is probably the worst of these early sites as regards terrain disturbance and site recovery. Substantial thermokarst subsidence had occurred along vehicle tracks and in the adjacent area. Debris, in the form of pilings, raised catwalks, and gas drums litter the surrounding area (Figure 10 b). Currently, Husky Oils is undertaking a clean-up program in the Reserve. Revegetation and thermokarst studies are being undertaken at Old Fish Creek by CRREL (Brown, 1977).

Fig.10(b) Debris at the Old Fish Creek wellsite, U.S. National Petroleum Reserve, (NPR-4), Alaska, June 30, 1977.

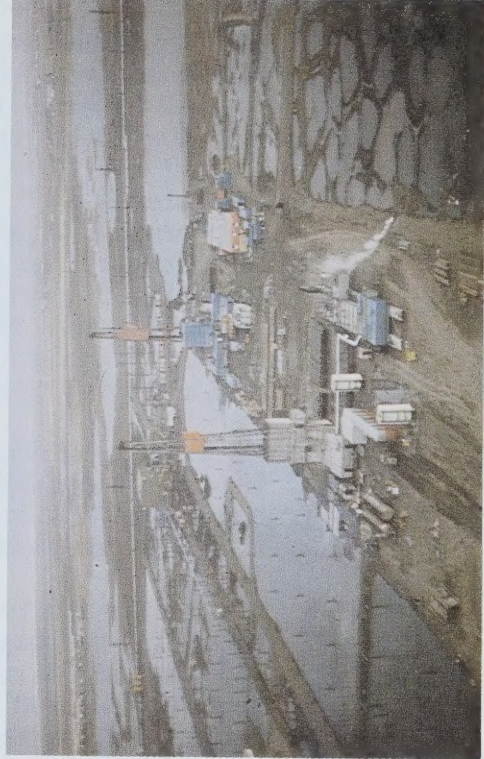
Fig.10(d) Air view of a multiple well drilling operation at Prudhoe Bay, Alaska, using large gravel pads and communal sump, June 30, 1977.
